Southern Water: Sandown Water Treatment Works

The Challenge

Southern Water Sandown Water Treatment Works

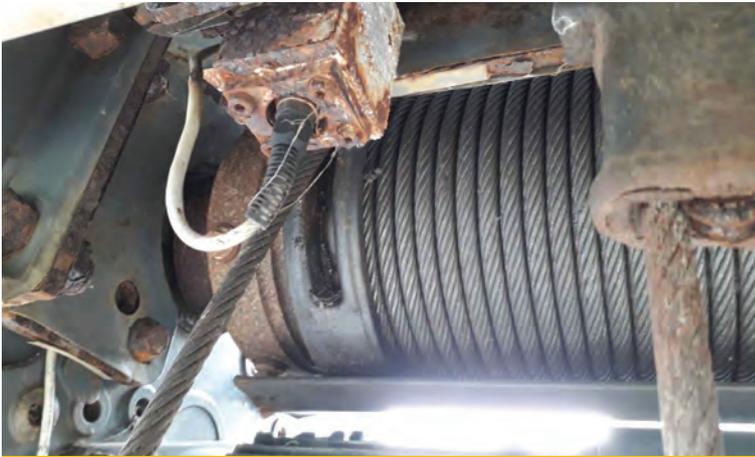
Corroded rope and dead-end assembly on original hoist

Faults identified through the planned service visit

- Extreme corrosion of the rope dead end assembly
- Damaged isolator covers
- Highly damaged weather covers.

Because of the extent of the damage to the hoist, and the parts and labour costs that a full repair would incur, it was decided that the best course of action would be to replace the entire hoist.

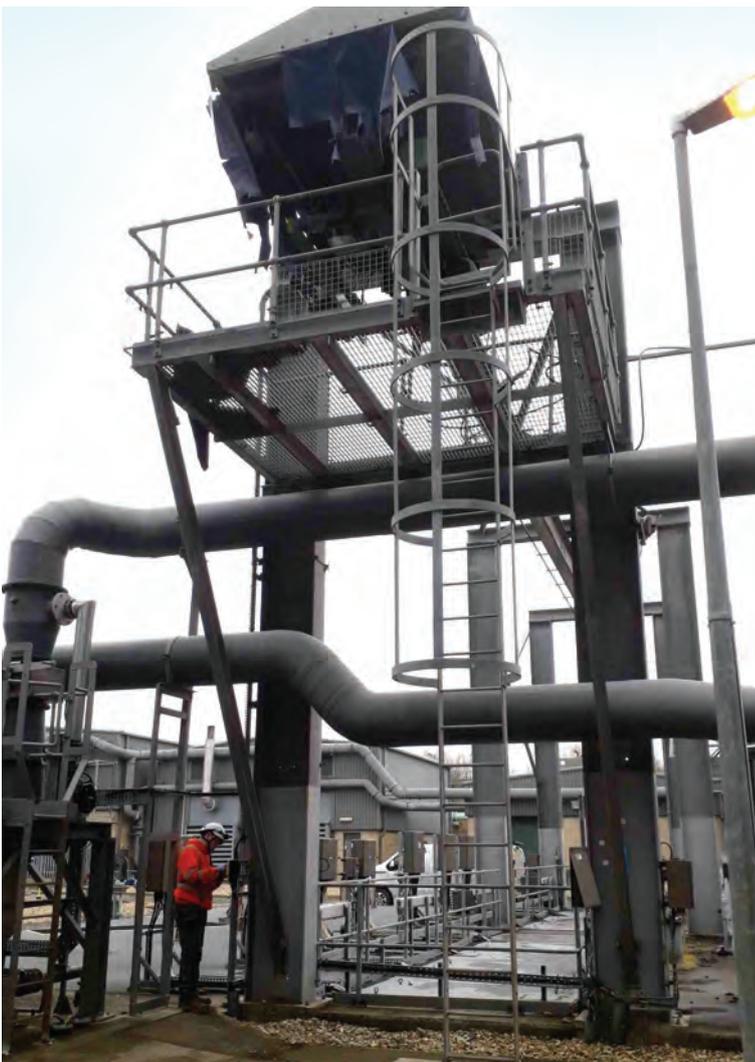
Damaged weather covers

Exposed to the elements

- Upon inspection of the weather cover, the extent of the damage was immediately evident.
- It was clear that the lack of protection from the damaged cover was a contributing factor to the heavy corrosion our engineers had found on the hoist.
- Street Cranexpress replaced the damaged weather cover with an updated, sturdier model.

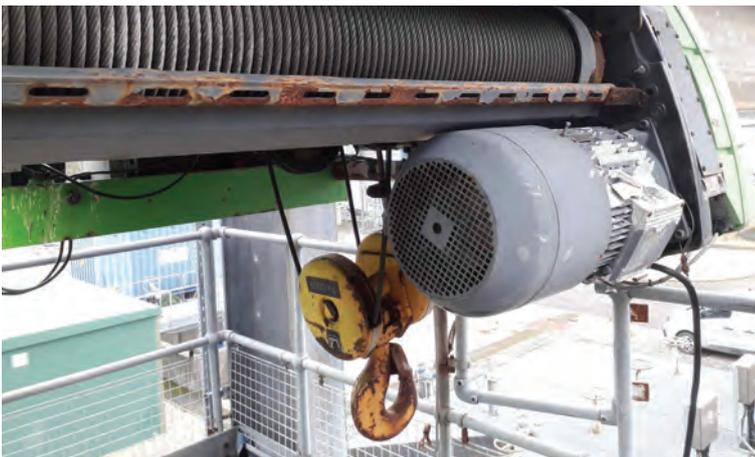
Further corrosion to original hoist steelwork and bottom block assembly

Ensuring a long lifespan for the new hoist

- The project included the addition of a weather cover to the hoist 'parking area', for protection of the hoist when not in use.
- The existing power feed festoon trolleys, towing trolley and cables were also replaced to ensure longevity.

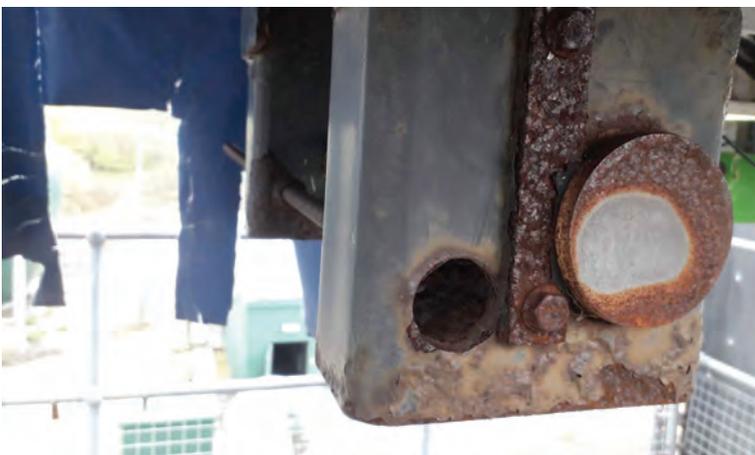
Further irreparable corrosion

Signs of wear

- The hoist was in a highly corroded state when our engineers arrived to complete their service.
- Corrosion is a natural process of deterioration, which is sped up by exposure to adverse weather; the process can be slowed by protection from the elements.
- When corrosion is found on any lifting equipment, the integrity of that part comes into question, and no risks can be taken.

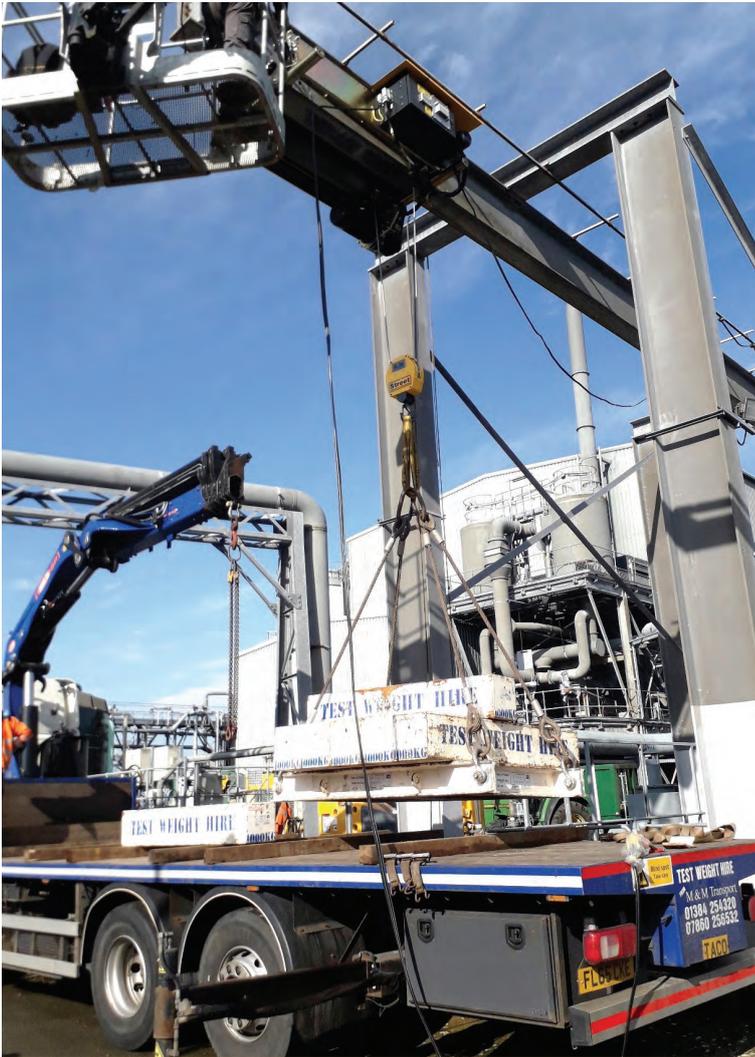
Street Cranexpress carrying out the proof load test of the newly installed Street hoist

Proof load testing

- After installation of the hoist, a proof load test was required.
- As per standard commissioning procedure, a proof load test of 125% of the Safe Working Load was carried out on site.
- The test was performed in a safe, controlled environment under a lifting plan that was devised by the senior engineer assigned to the job.
- The new hoist successfully passed the load test and overload devices were set in the process.

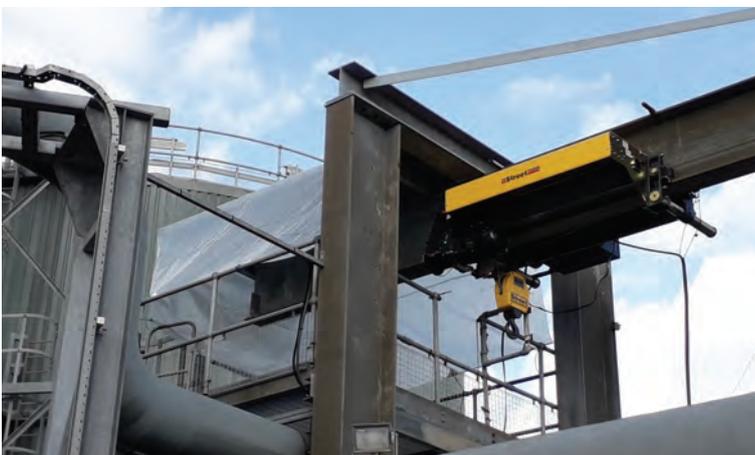
New hoist in situ

- The existing hoist unit was disconnected from the electrical power supply, before being mechanically disconnected from the runway beam and lowered to floor level.
- A new hoist unit was supplied and installed by our skilled overhead crane engineers.
- A proof load test and a Report of Thorough Examination were produced once the new hoist had been installed.
